# **BAREFOOT TRACE CONDOMINIUM**

St. Augustine, Florida

## **FACILITY CONDITION ASSESSMENT**

### **Survey Report and Results**

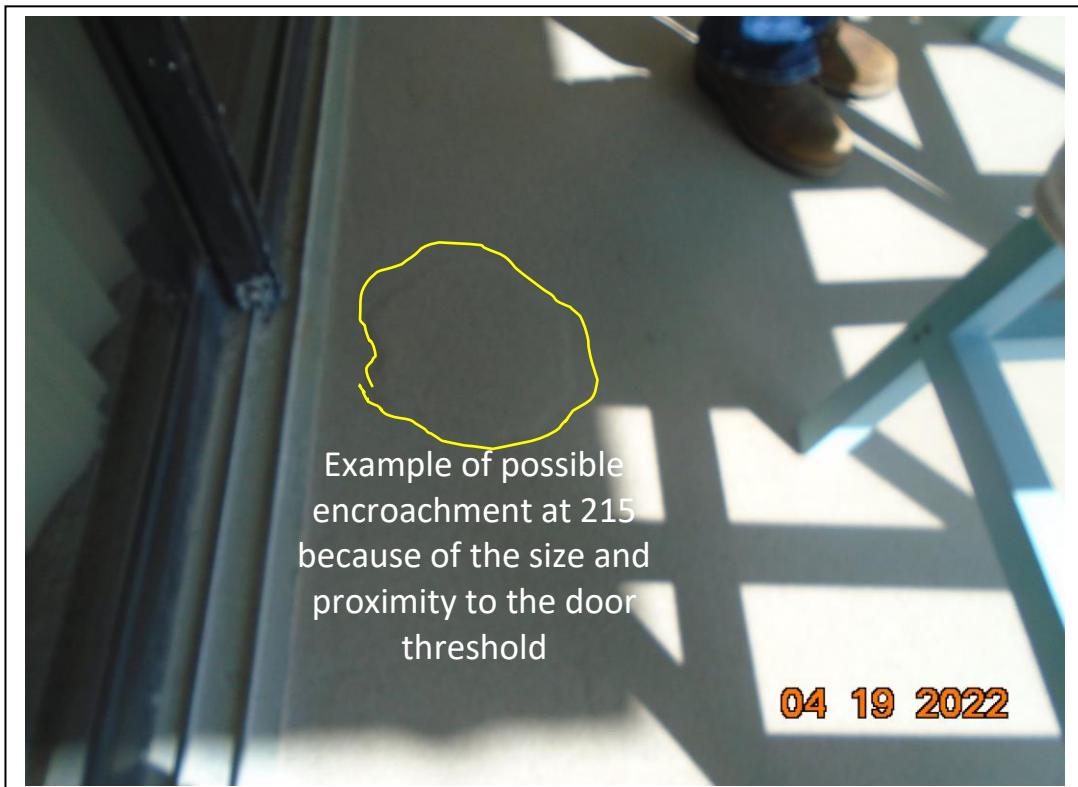
Example of possible  
encroachment at 215  
because of the size and  
proximity to the door  
threshold

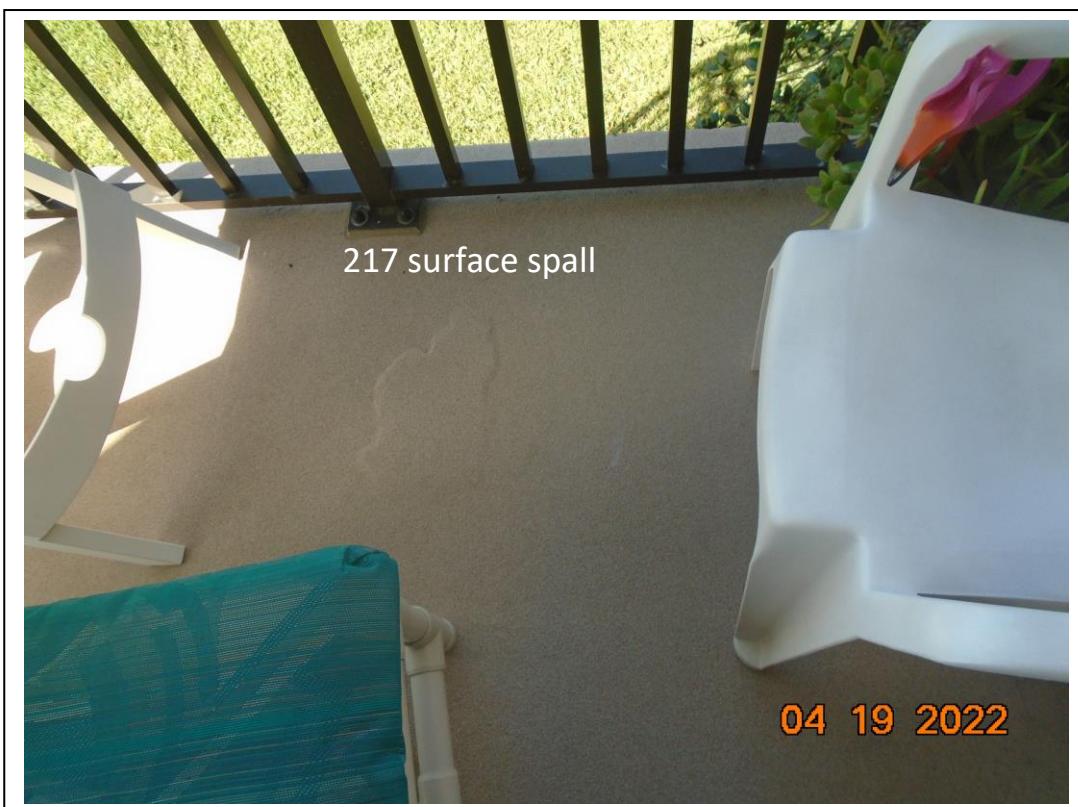
217 surface spall

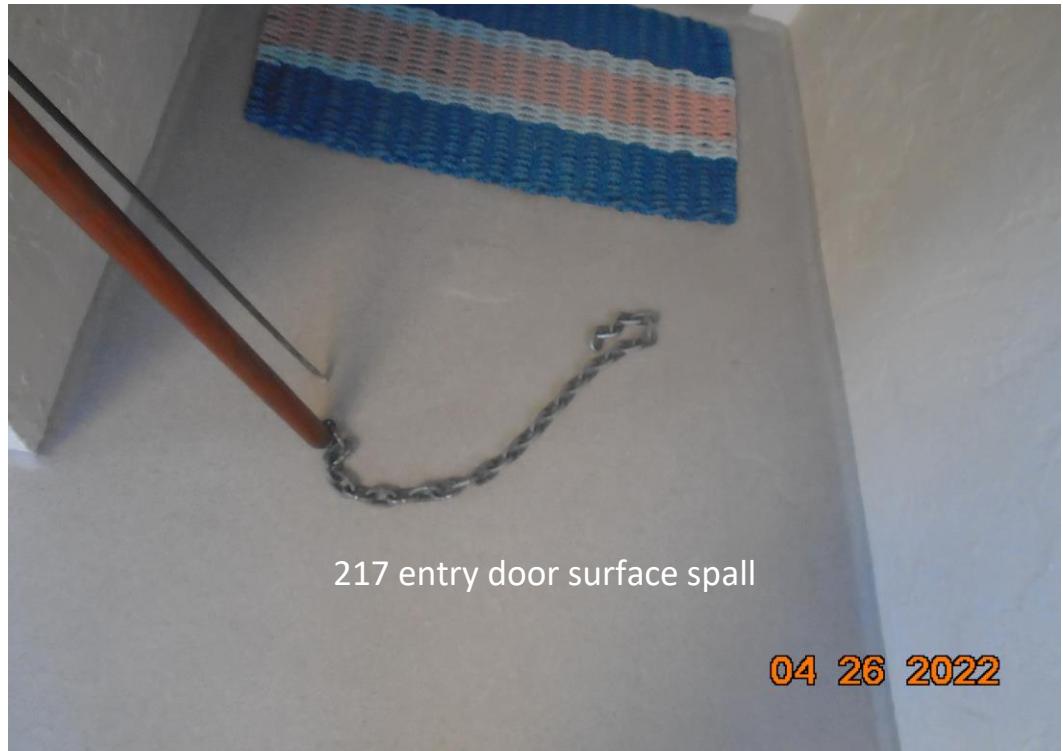
217 entry door surface spall

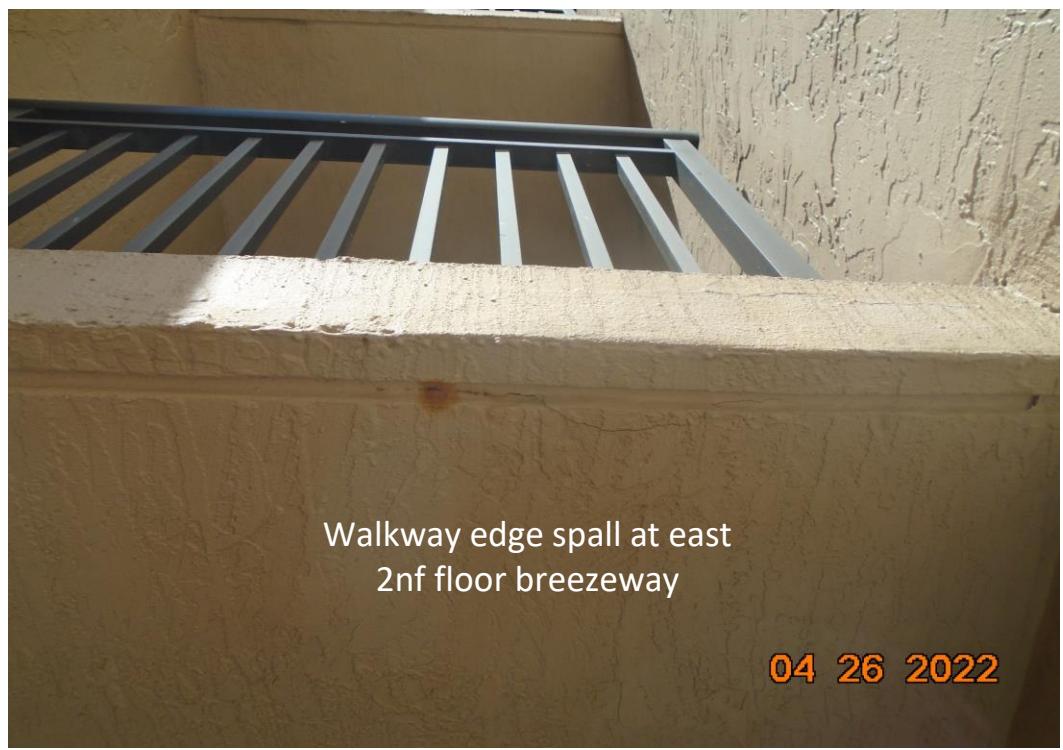
Walkway edge spall at east  
2nf floor breezeway

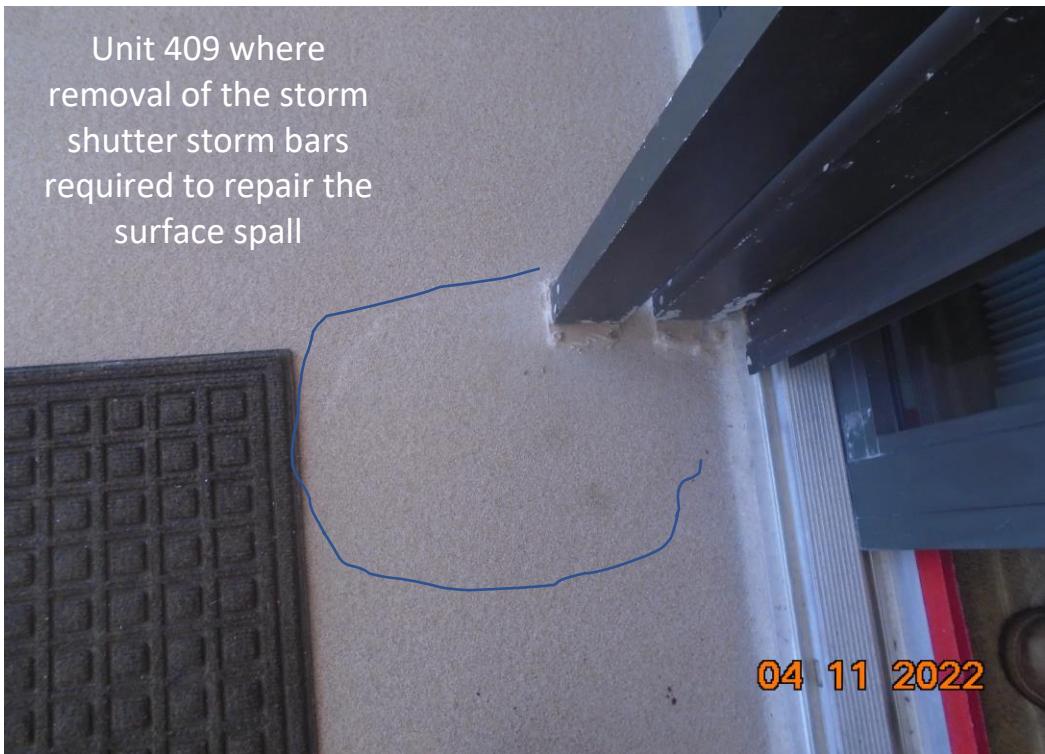
Unit 409 where  
removal of the storm  
shutter storm bars  
required to repair the  
surface spall

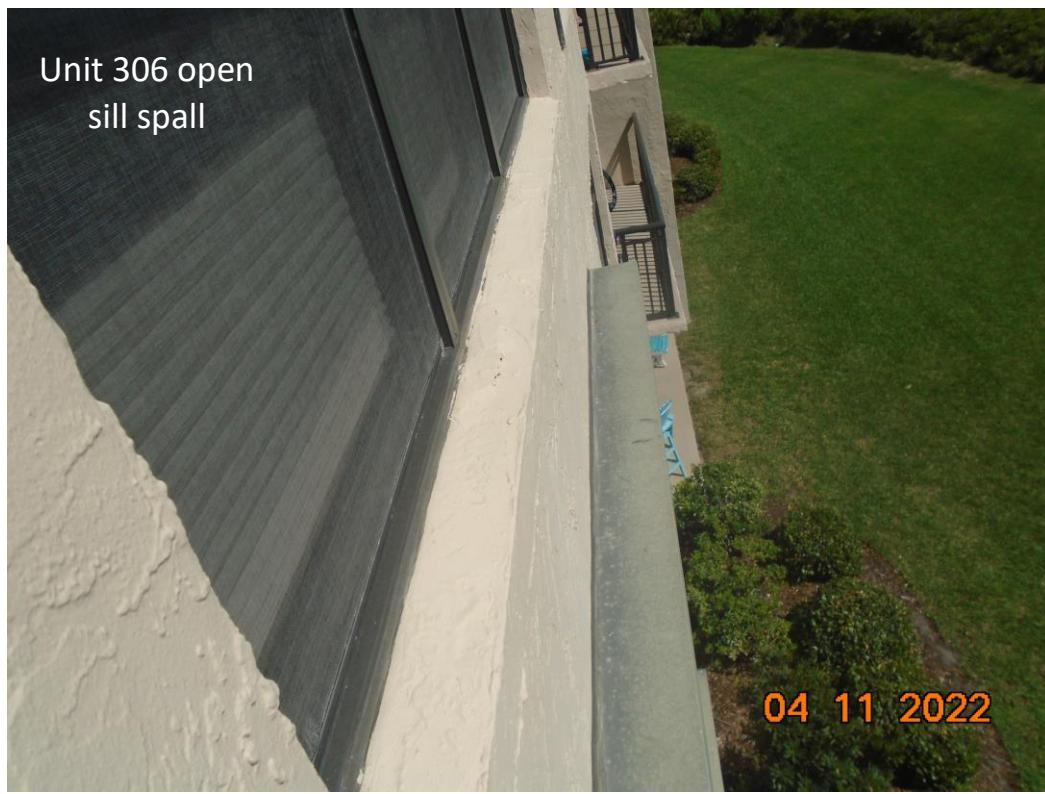
Unit 306 open  
sill spall

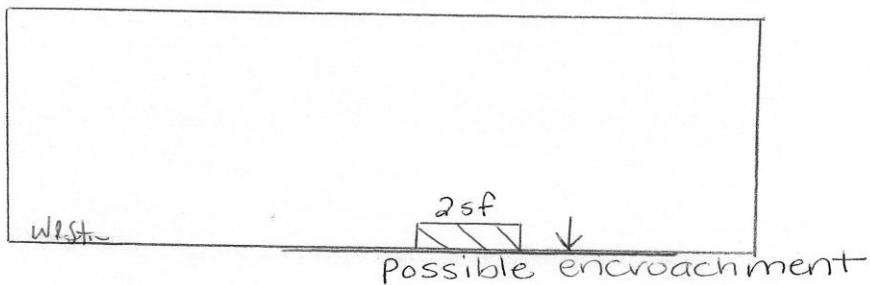
Barefoot Trace Unit: 401

LR-balcony - Shutter

Seal Light

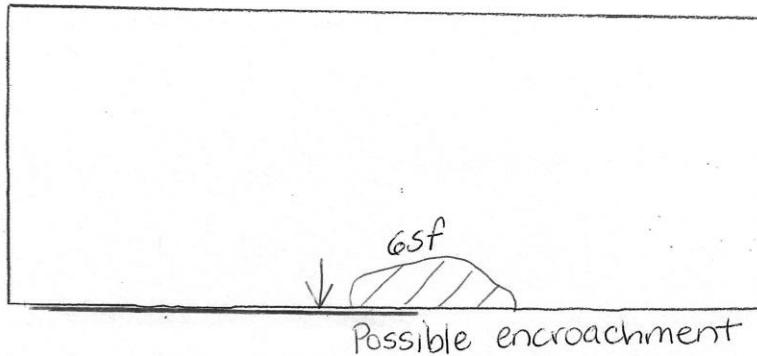
Barefoot Trace Unit: 405

Seal Light and Receptacle

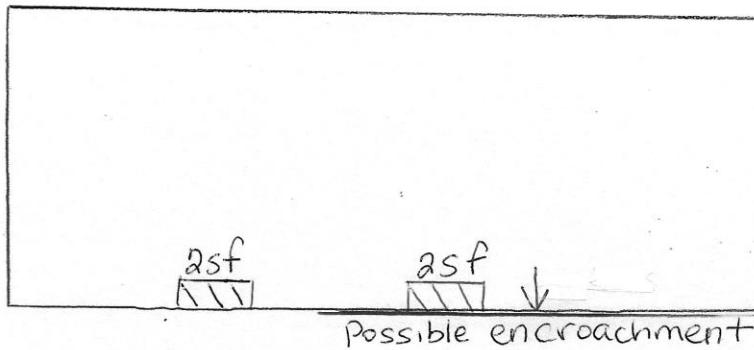
Barefoot Trace Unit: 406

Light and receptacle not Sealed

MBR Windows unsealed

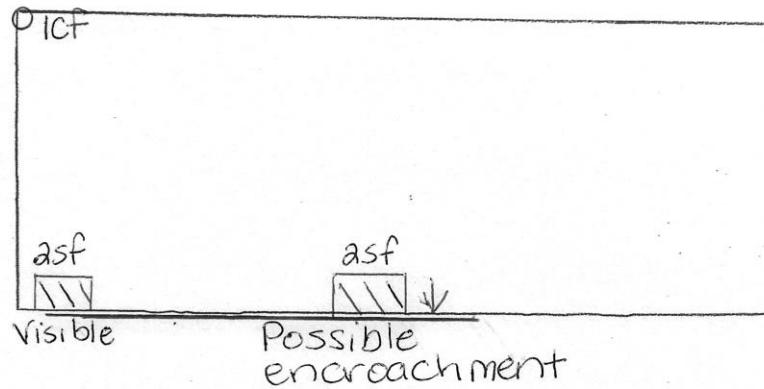
Barefoot Trace Unit: 407

Light and receptacle unsealed

rust bleeding from light

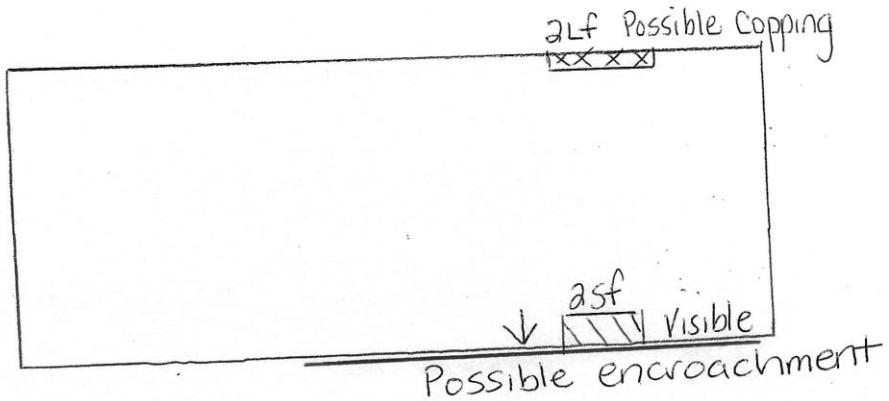
Barefoot Trace Unit: 408

Seal light and receptacle

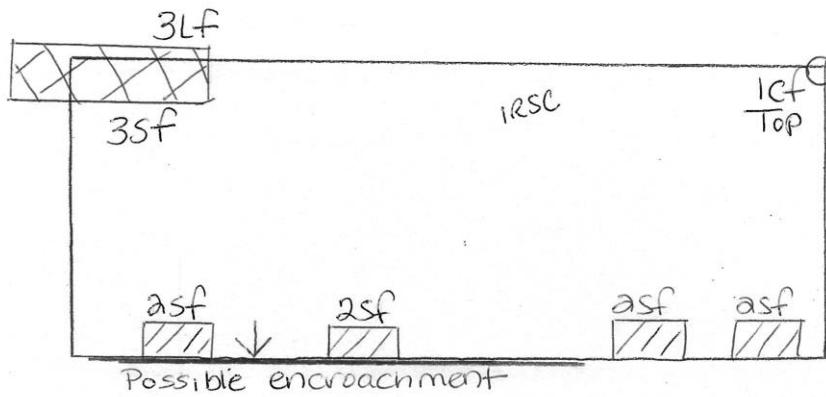
Barefoot Trace Unit: 409

Seal light and receptacle

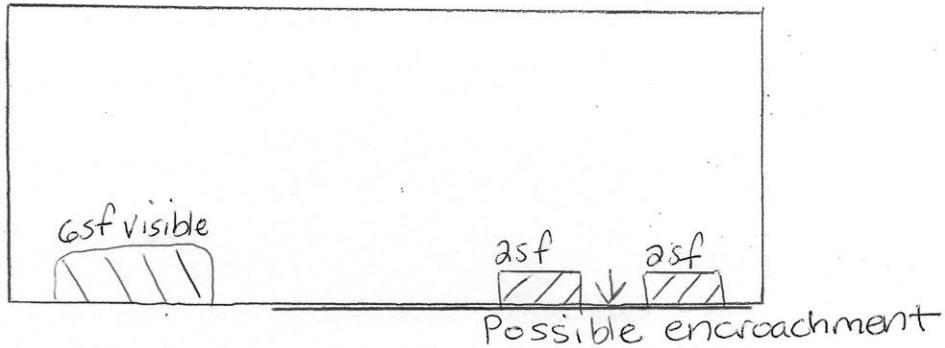
Barefoot Trace Unit: 411

Seal Light and Receptacle

MBR window - replace Sealant

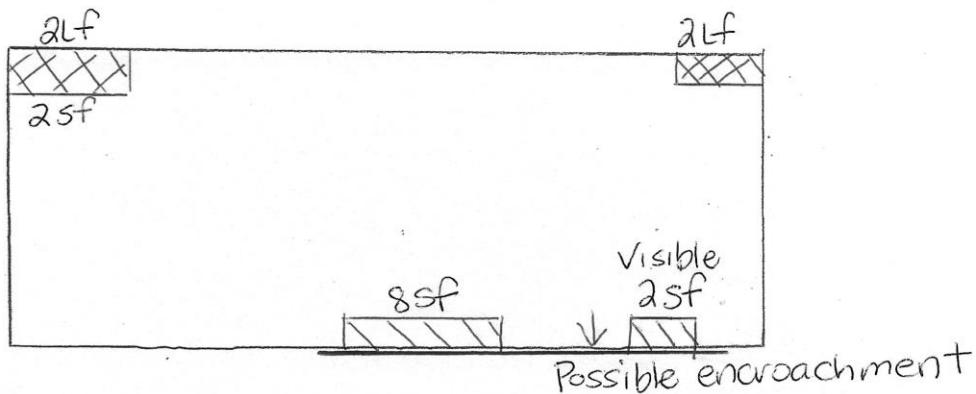
Barefoot Trace Unit: 413

Seal light and receptacle

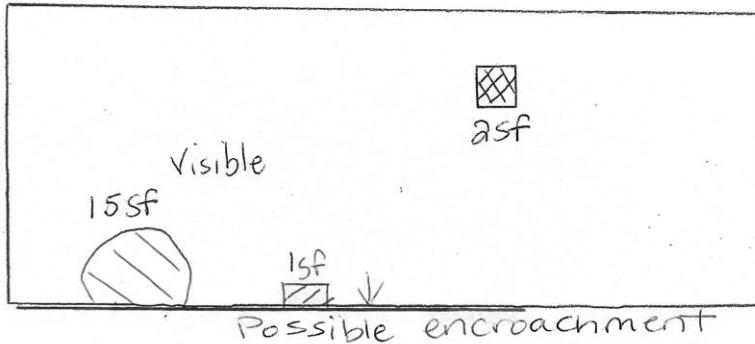
Barefoot Trace Unit: 414

Seal Light and Receptacle

Rusted Anchors on receptacle conduit

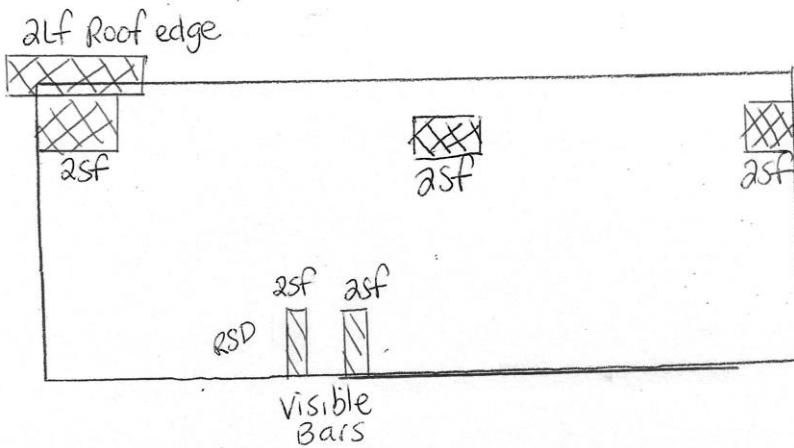
Barefoot Trace Unit: 415

Seal Light and receptacle

Rusted Anchors in junction box conduit

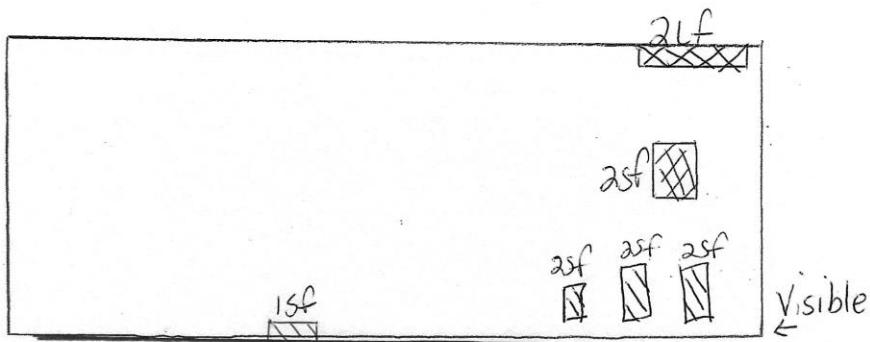
Barefoot Trace Unit: H16

Seal light and receptacle

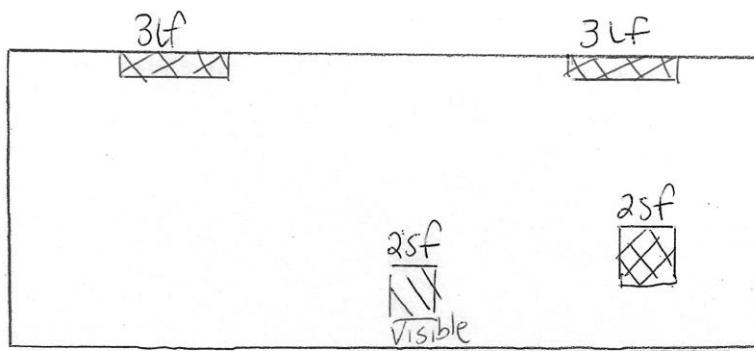
Barefoot Trace Unit: 417

Seal light and receptacle

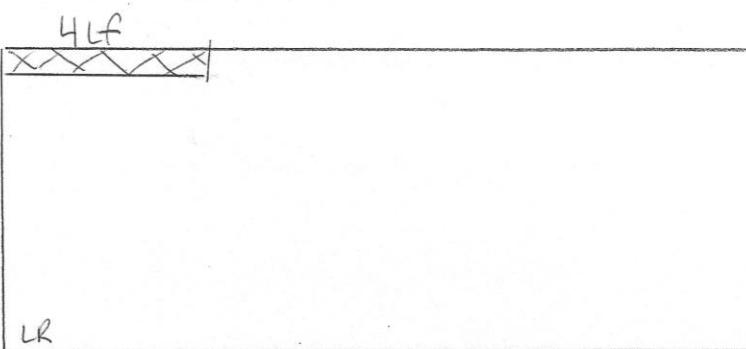
Barefoot Trace Unit: 301

LR - Seal light

Door need track insert

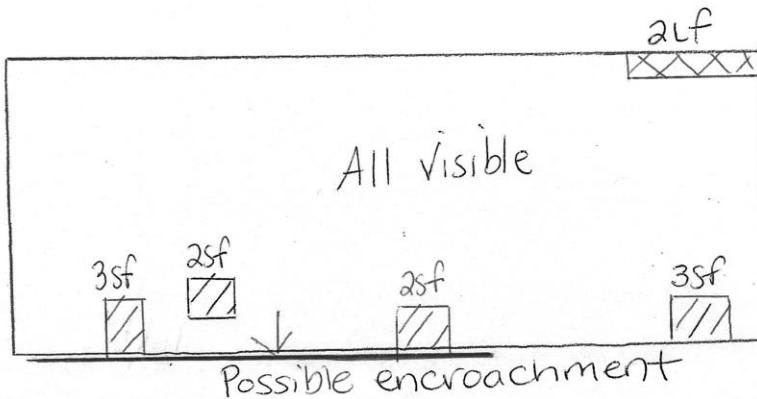
Barefoot Trace Unit: 307

Seal light and receptacle

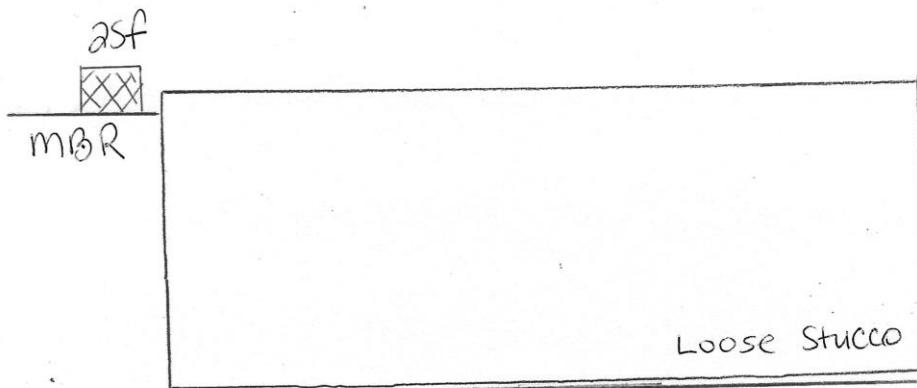
Barefoot Trace Unit: 308

Seal light and receptacle

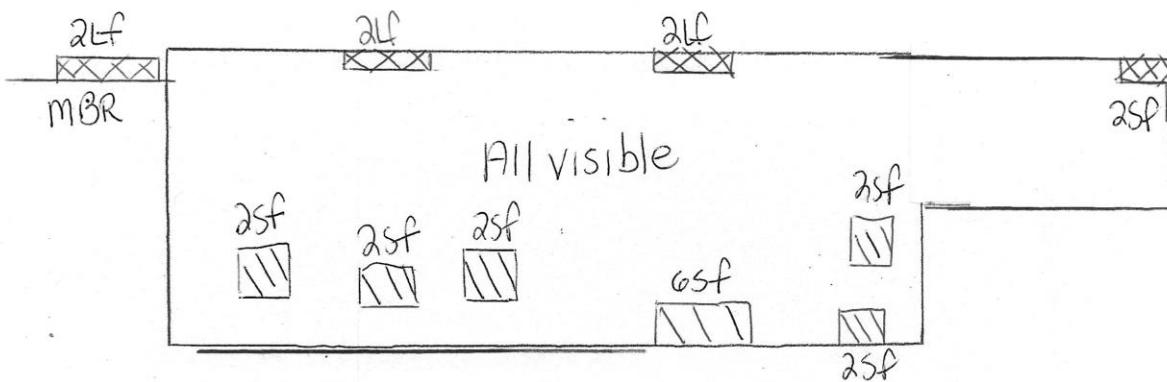
Barefoot Trace Unit: 309

Seal light and receptacle

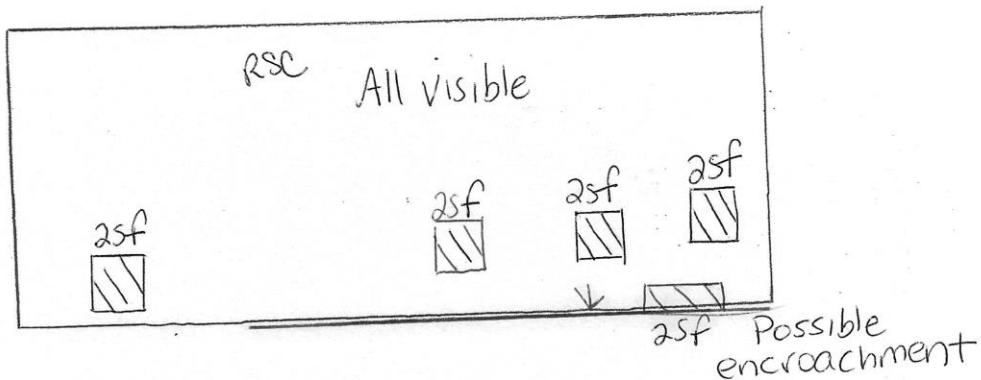
Barefoot Trace Unit: 311

Seal Light and receptacle

Can't bead on All base plates

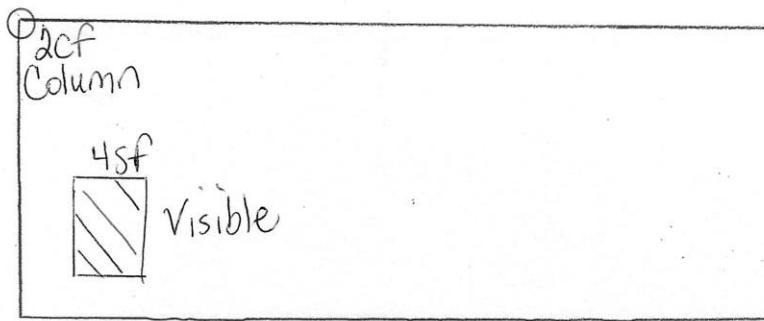
Barefoot Trace Unit: 312

Seal light and receptacle

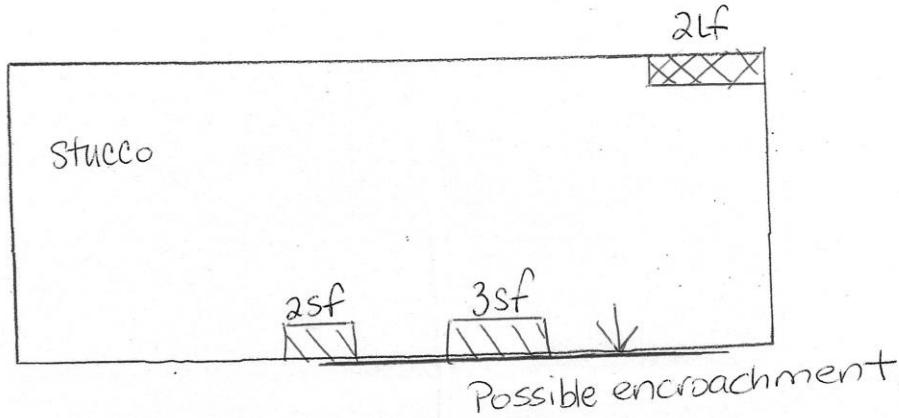
Barefoot Trace Unit: 313

Seal light and receptacle

threshold oxidizing on SGD

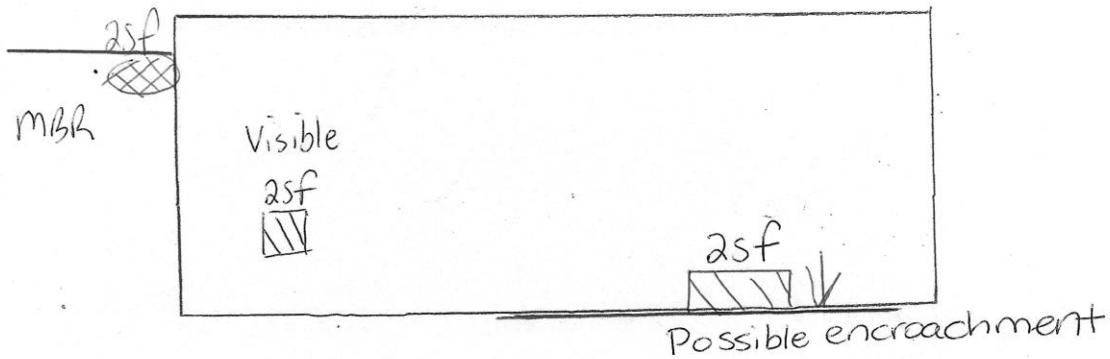
Barefoot Trace Unit: 314

Seal light and receptacle

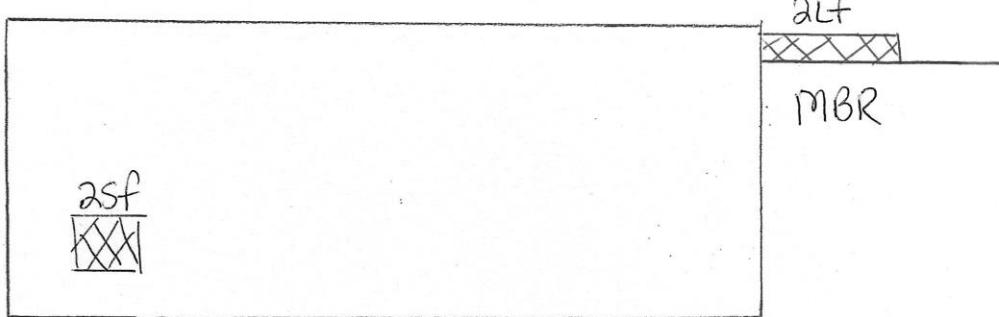
Barefoot Trace Unit: 316

SGD wet zone not Sealed

Seal light and receptacle

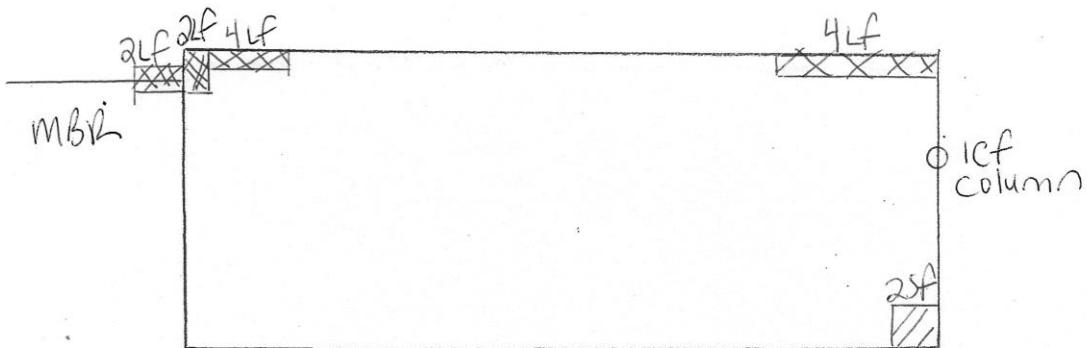
Barefoot Trace Unit: 317

Seal Light and Receptacle

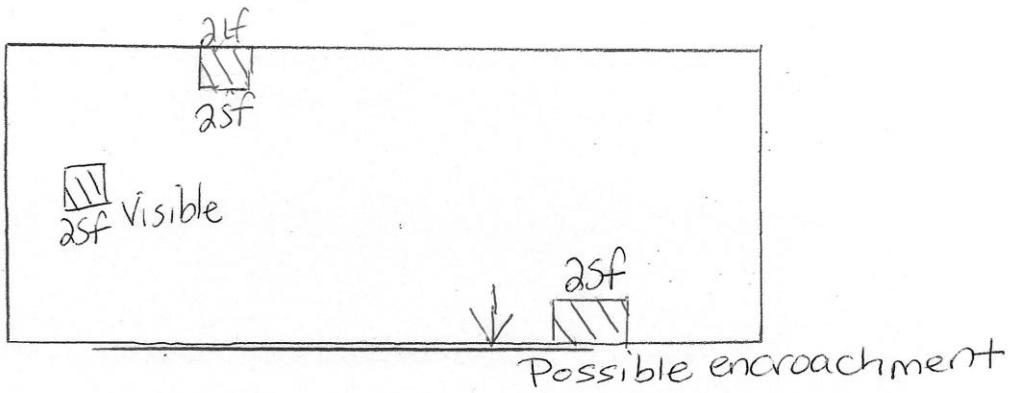
Barefoot Trace Unit: 202

Seal Light and Receptacle

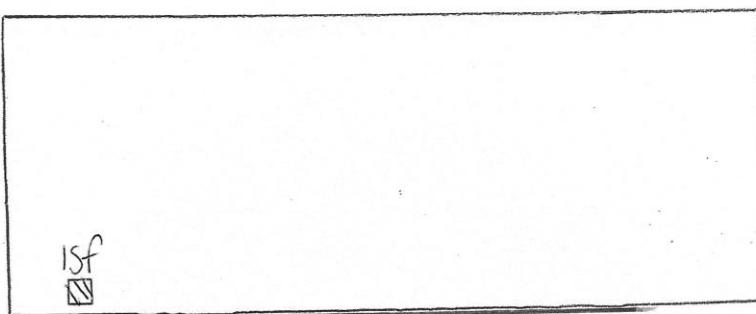
Barefoot Trace Unit: 210

Seal light and receptacle

MBR window sealant Alligatored & failed

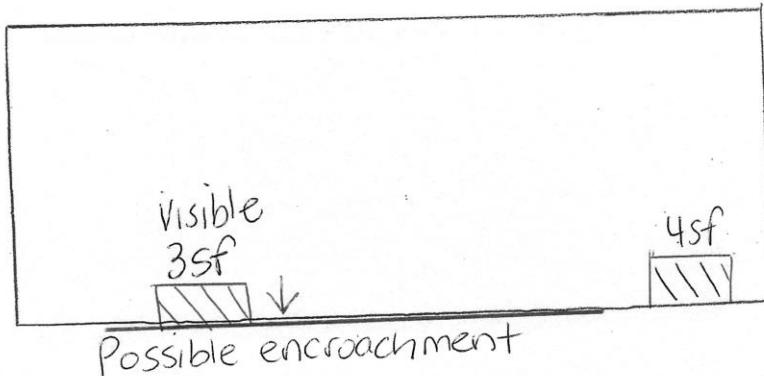
Barefoot Trace Unit: 212

Seal light and receptacle

Track on SGD is corroding making it  
difficult to open

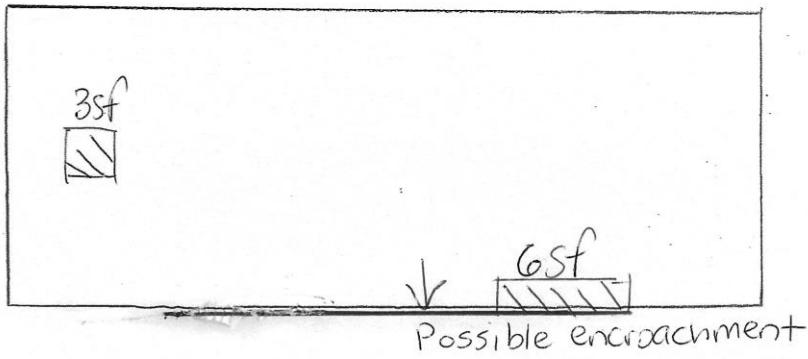
Barefoot Trace Unit: 213

Seal light and receptacle

Can't bead on btm of window

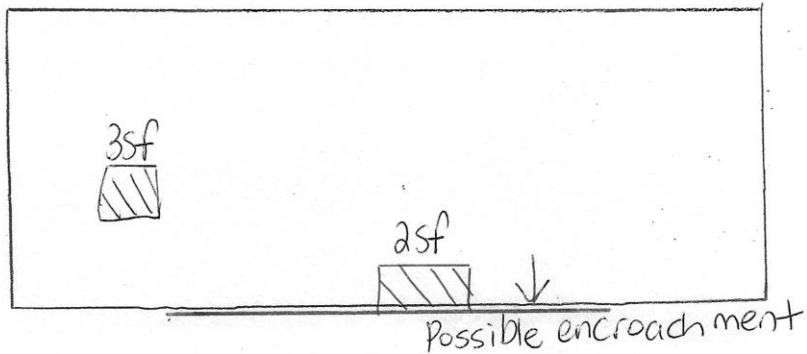
Barefoot Trace Unit: 214

Seal light and receptacle

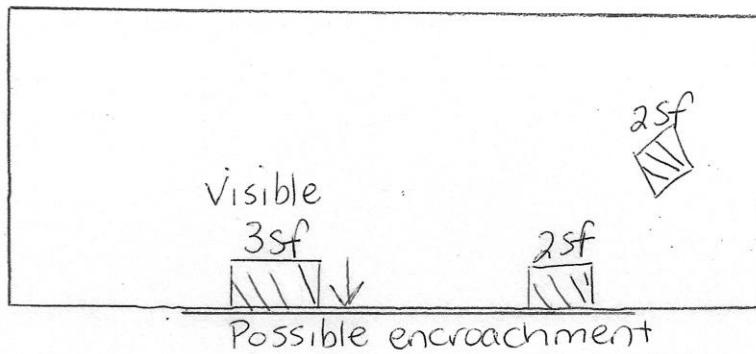
Barefoot Trace Unit: 215

Seal Receptacle and light

S6D Seal broken

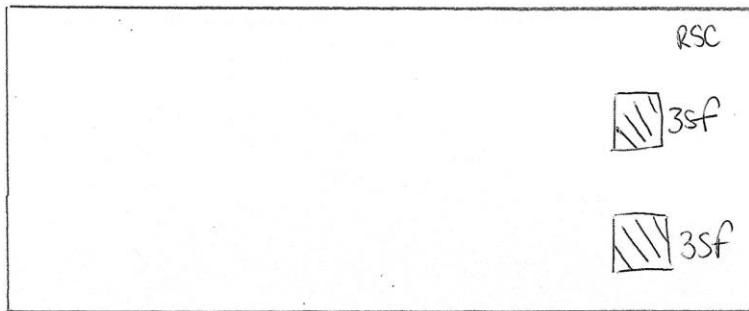
Barefoot Trace Unit: 217

Seal light and receptacle on both  
balconies

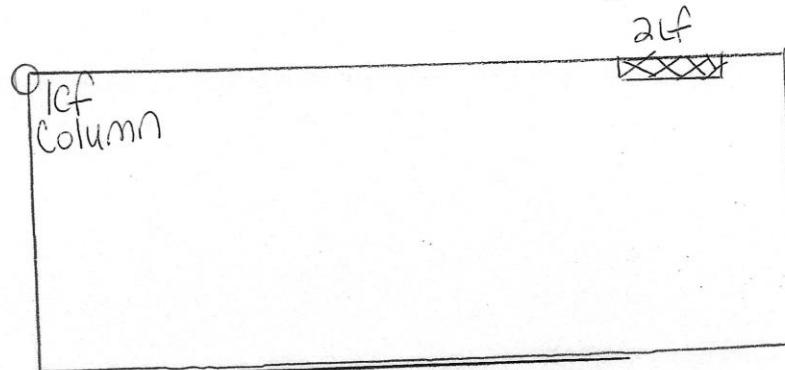
Barefoot Trace Unit: 101

Seal light and receptacle

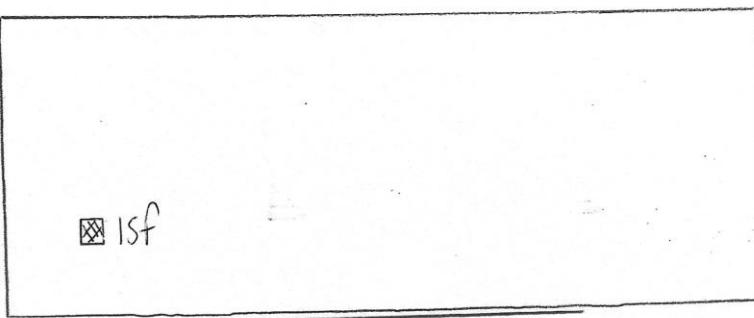
Barefoot Trace Unit: 102

Seal light and receptacle

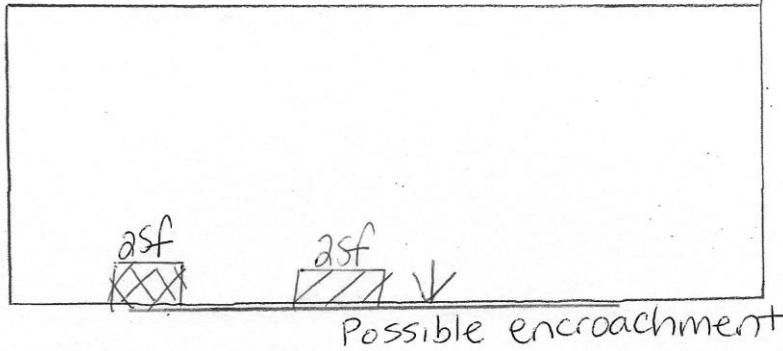
Barefoot Trace Unit: 103

Seal light and receptacle

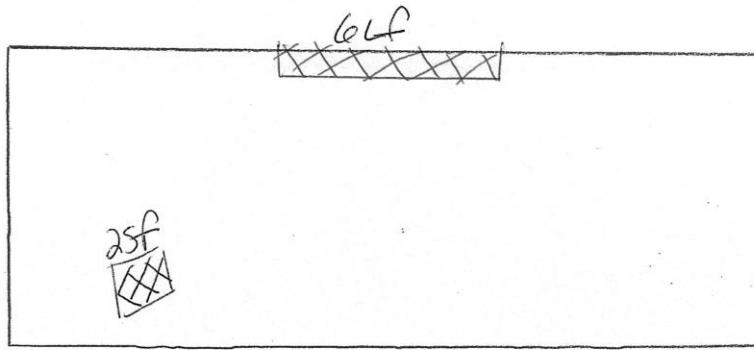
Barefoot Trace Unit: 116

Seal light and receptacle
