## TOTAL QUANTITIES FOR RECORD OF REPAIR #2

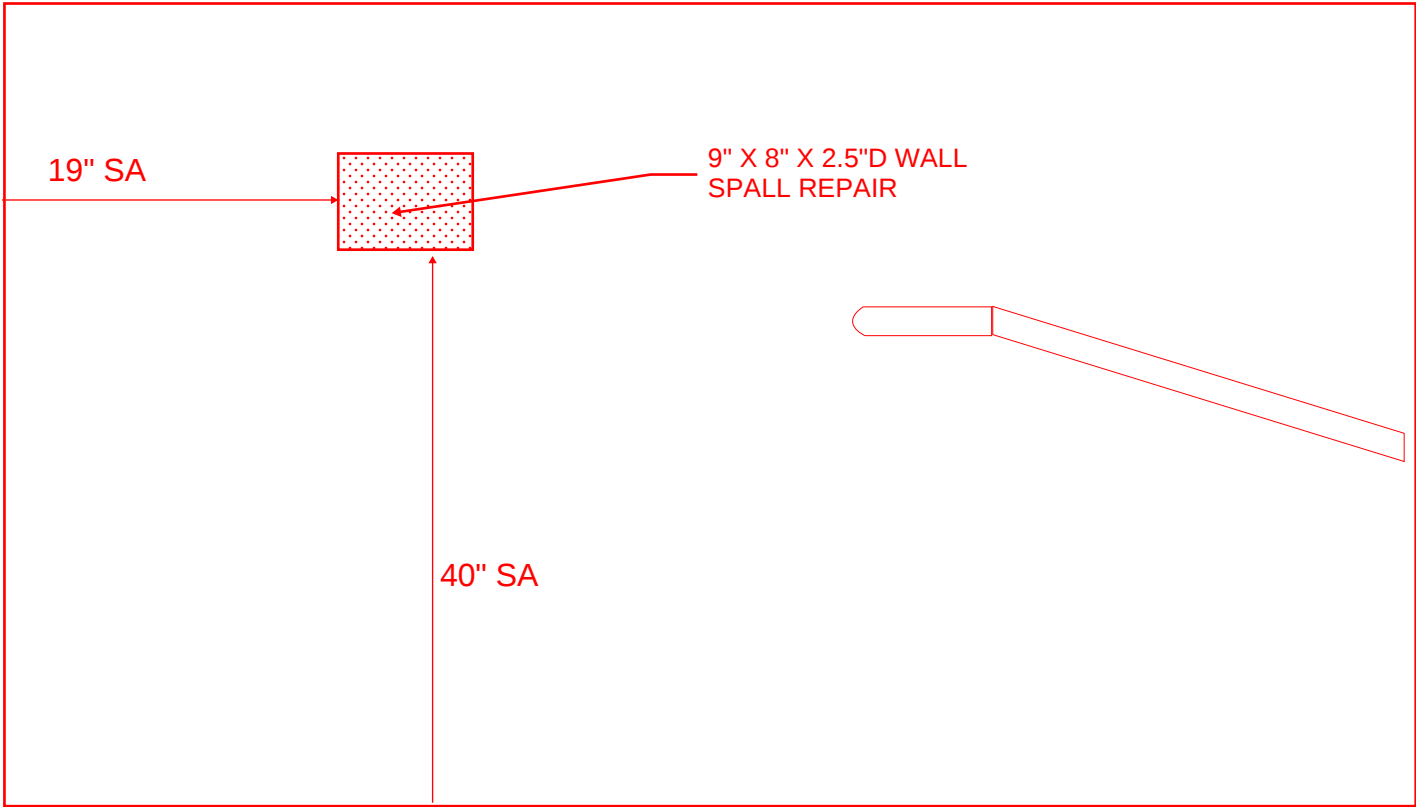
FAR NORTH BREEZEWAY STAIRWELL 3RD-4TH MIDLANDING  
SOUTH WALL LOOKING SOUTH

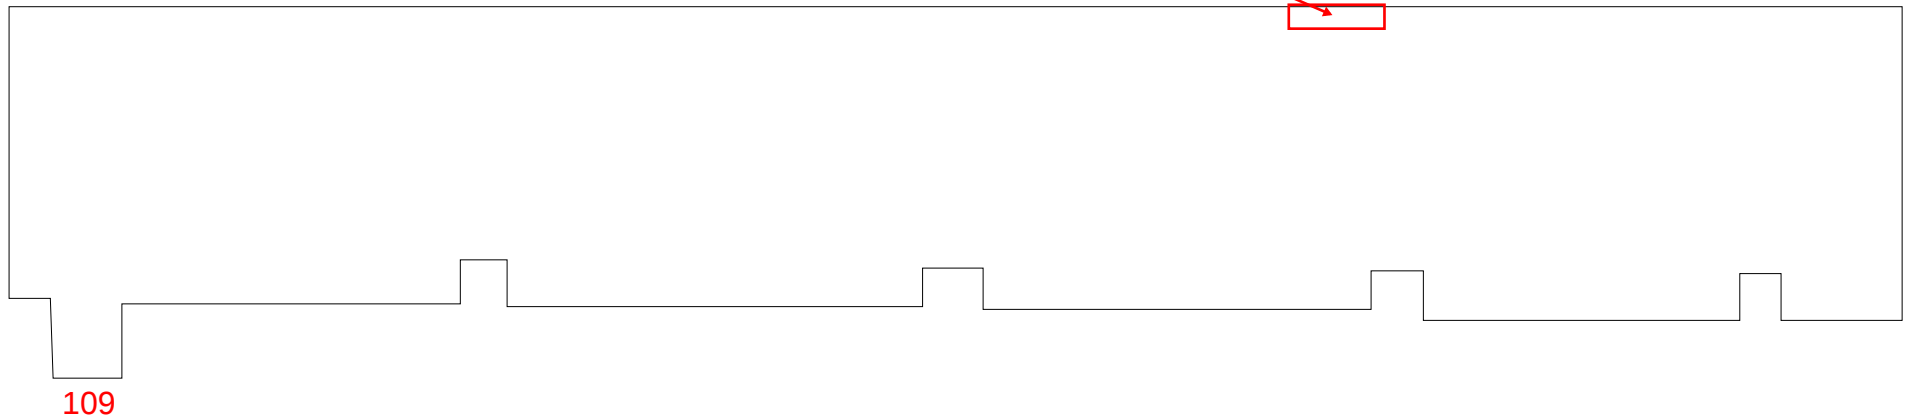
FLOOR 1  
AREA 3

21" EDGE + 21" X 1"  
OVERHEAD

171" SA
