## TOTAL QUANTITIES FOR RECORD OF REPAIR #3

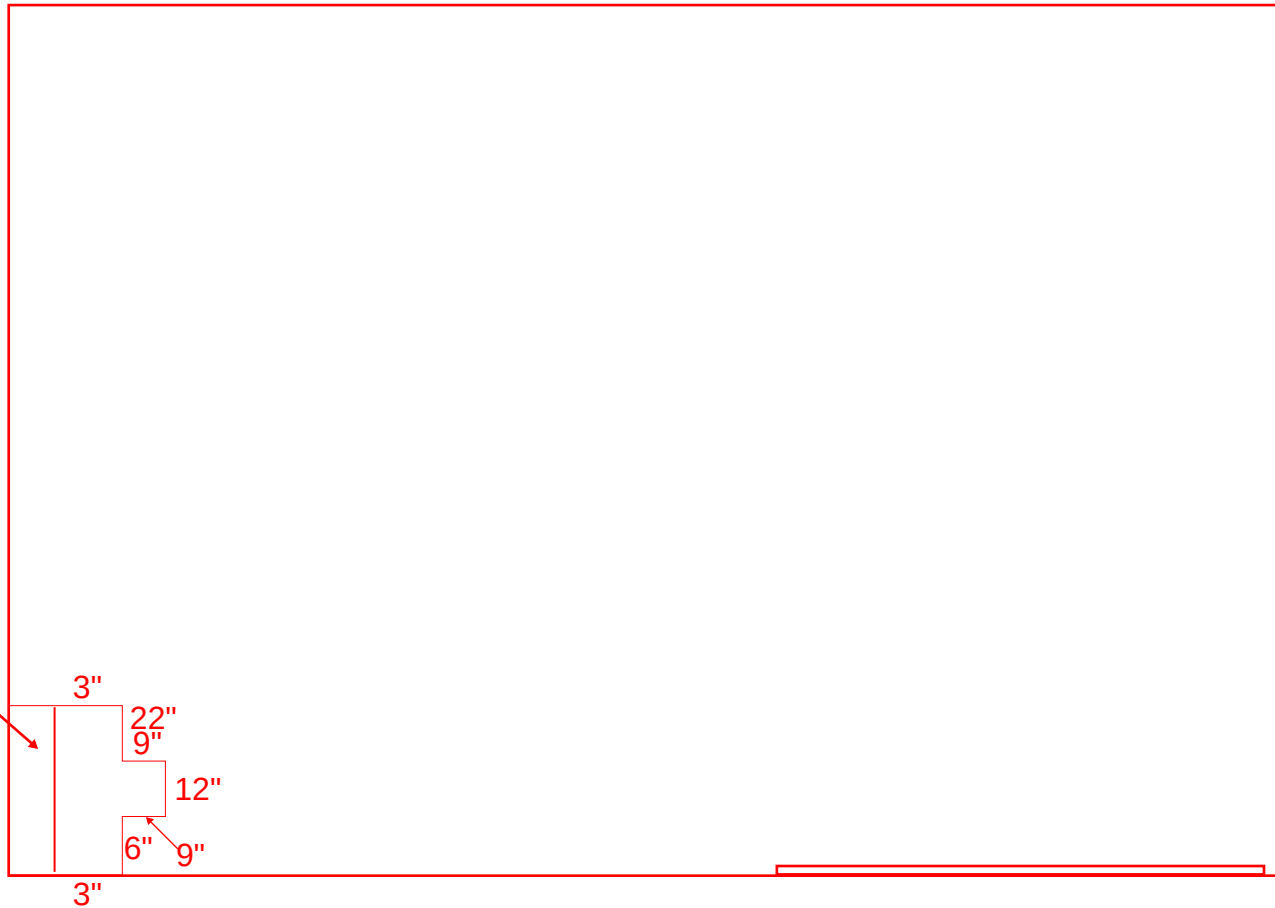
UNIT 417W

50" EDGE

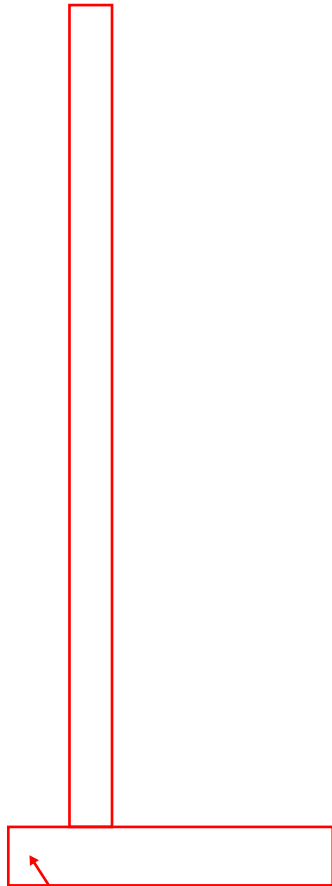
3RD EMBED ON WEST  
SIDE

8" X 7" X 4" CURB

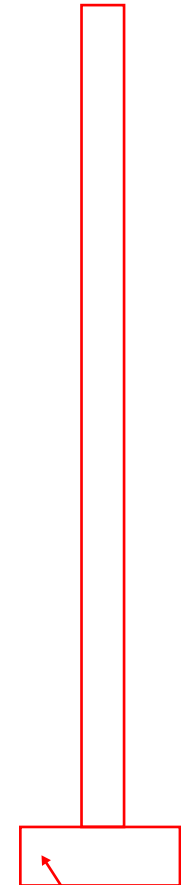
13TH EMBED ON WEST  
SIDE

18" X 6" X 6" CURB

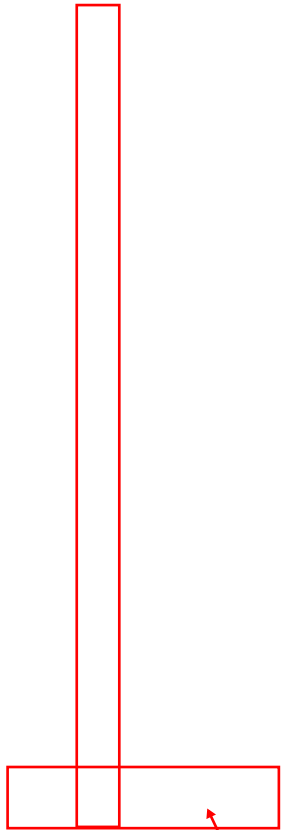
7TH

26" X 6" X 6" CURB

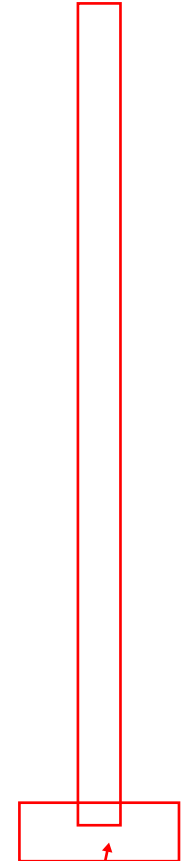
10TH

9" X 6" X 6" CURB

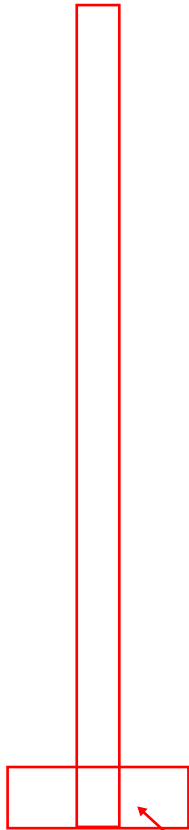
13TH

13" X 6" X 6" CURB

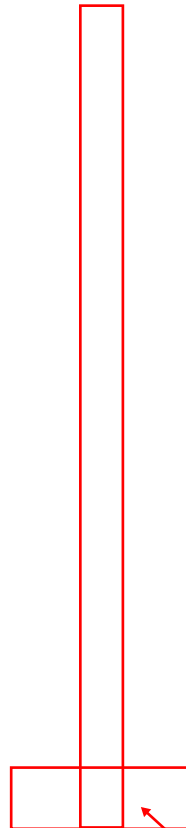
21ST

10" X 6" X 6" CURB

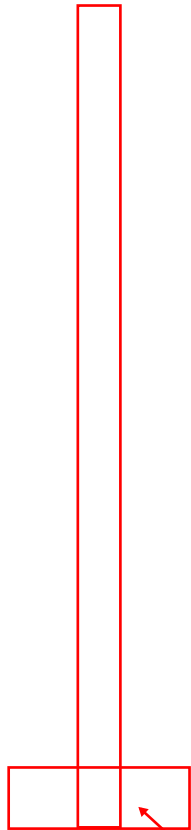
6TH

16" X 6" X 6" CURB

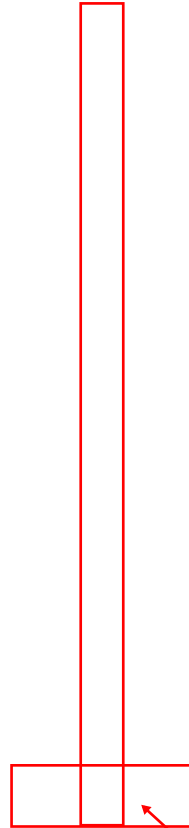
7TH

29" X 6" X 6" CURB

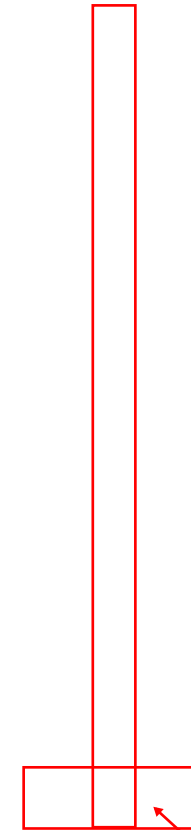
8TH

12" X 6" X 6" CURB
