BAREFOOT TRACE REHABILITATION PROJECT

Project Summary: #5

Reporting Period: 10-26-2024 through 11-08-2024

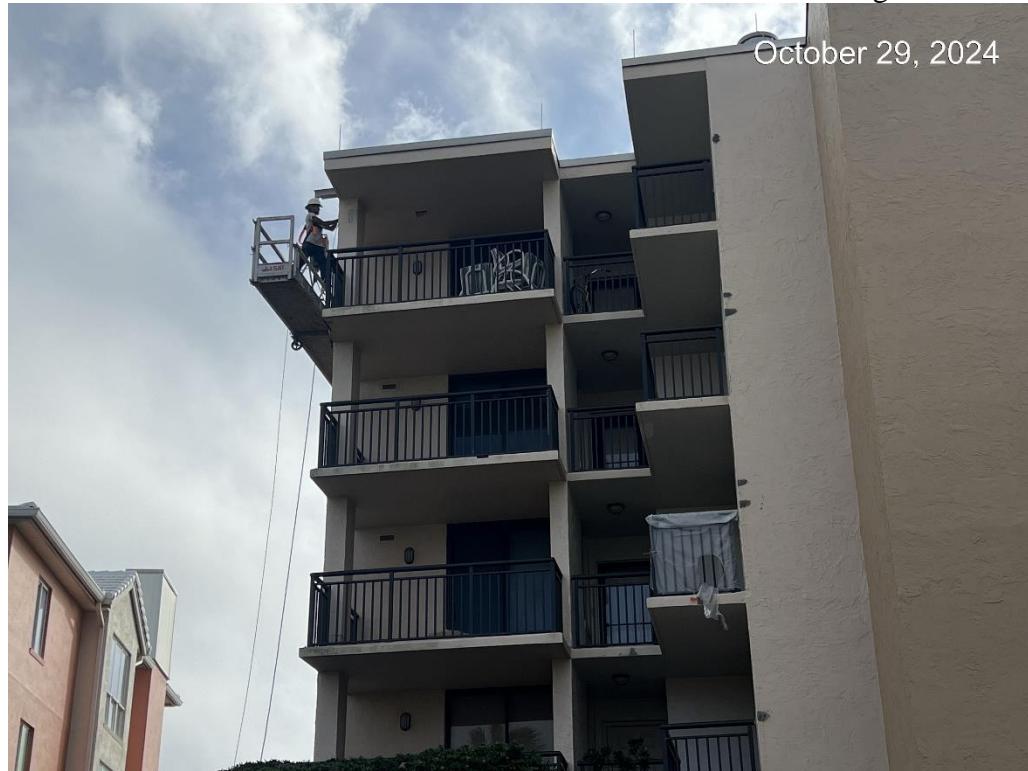
Figure 1. Photo of 01-West Stack with RL James Employees Working.

While commencing work on the south side of the building, the crew continued to complete work on the 01-west balconies, performing excavations, and casting concrete repair areas.

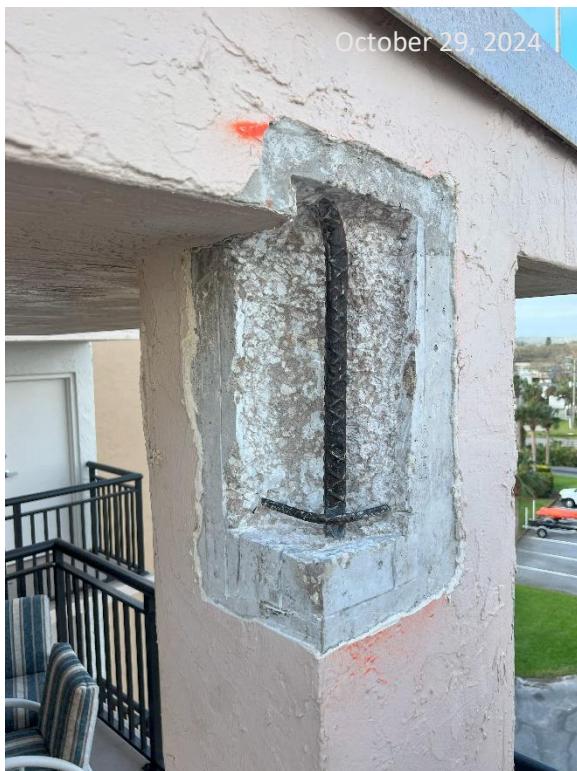
Figure 2. Column Repair Area. Unit 401.

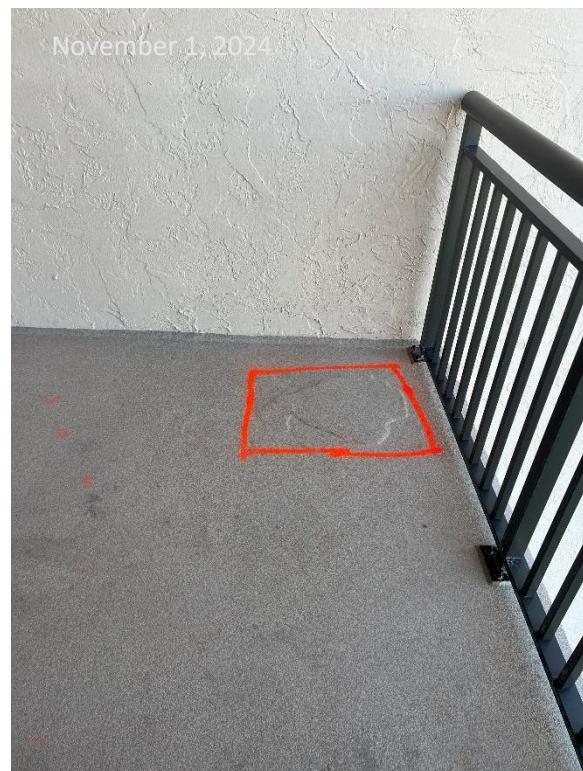
Figure 3. Square Patch Area Painted by Keystone. Unit 316.

Keystone personnel were called to the project site on 11/01/2024 and 11/06/2024 to paint out repair areas that were experiencing reinforcing steel corrosion on the 16-17-stack balconies and the parking deck respectively. These markings have rectangular geometry and give the contractor clearance to start excavating these areas.

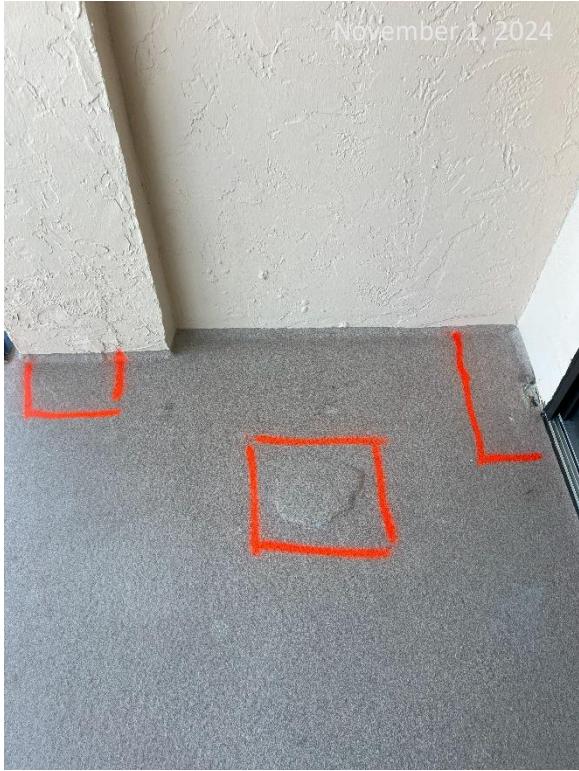
Figure 4. Painted out Repair Areas. Unit 217E

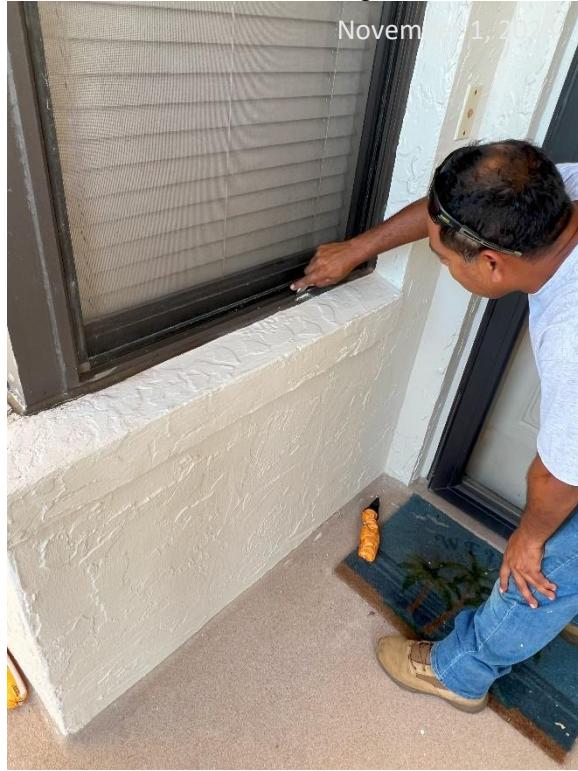
Figure 5. RL James Employee Removing Failed Sealants.

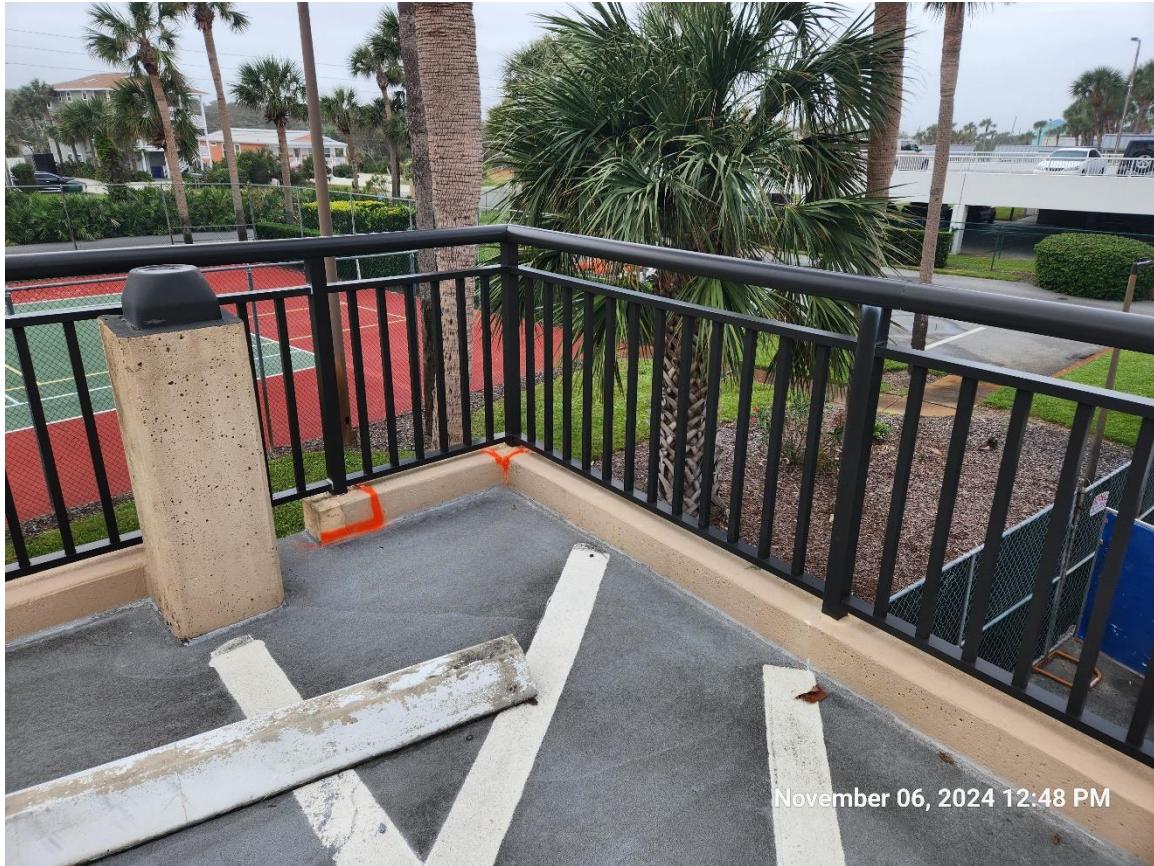
Figure 6. Parking Deck Areas Marked by Keystone.

RL James is scheduled to commence work on the parking deck on 11/11/2024, where they'll begin demolishing areas marked out by the project engineer while grinding the existing coating off the deck.

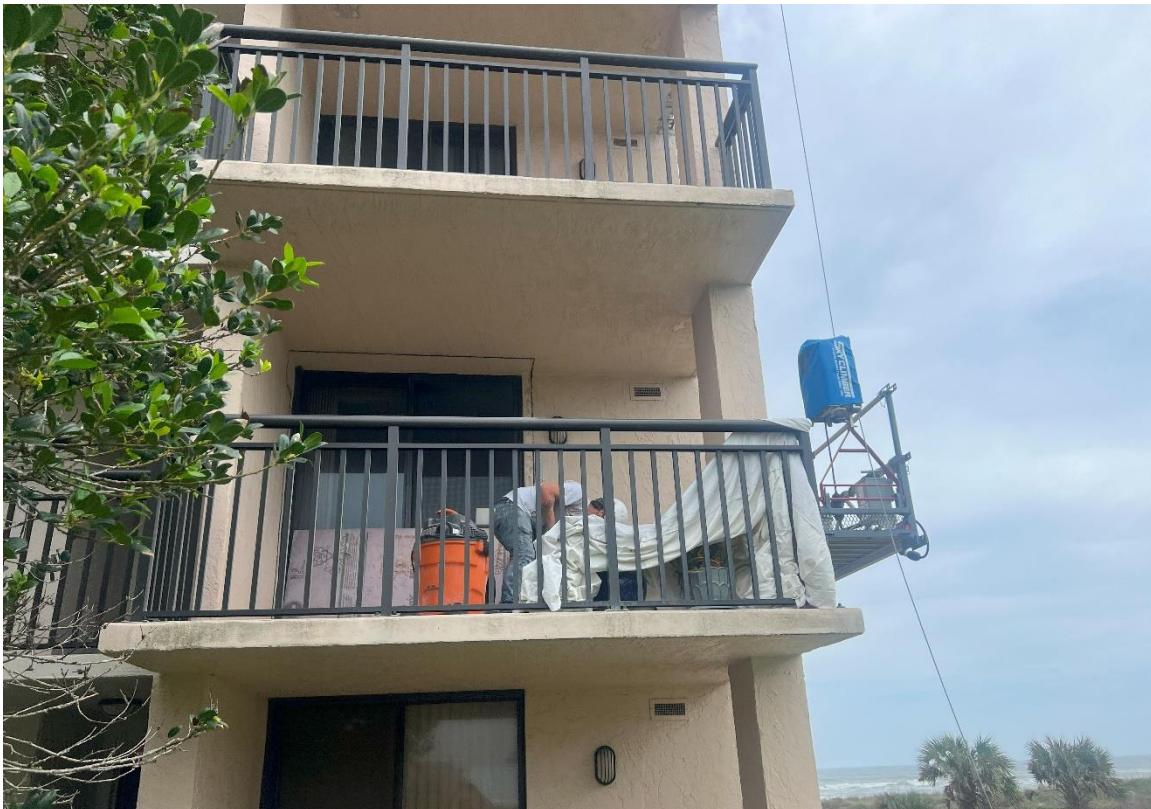
Figure 7. RL James Employee Working on Unit 217W.

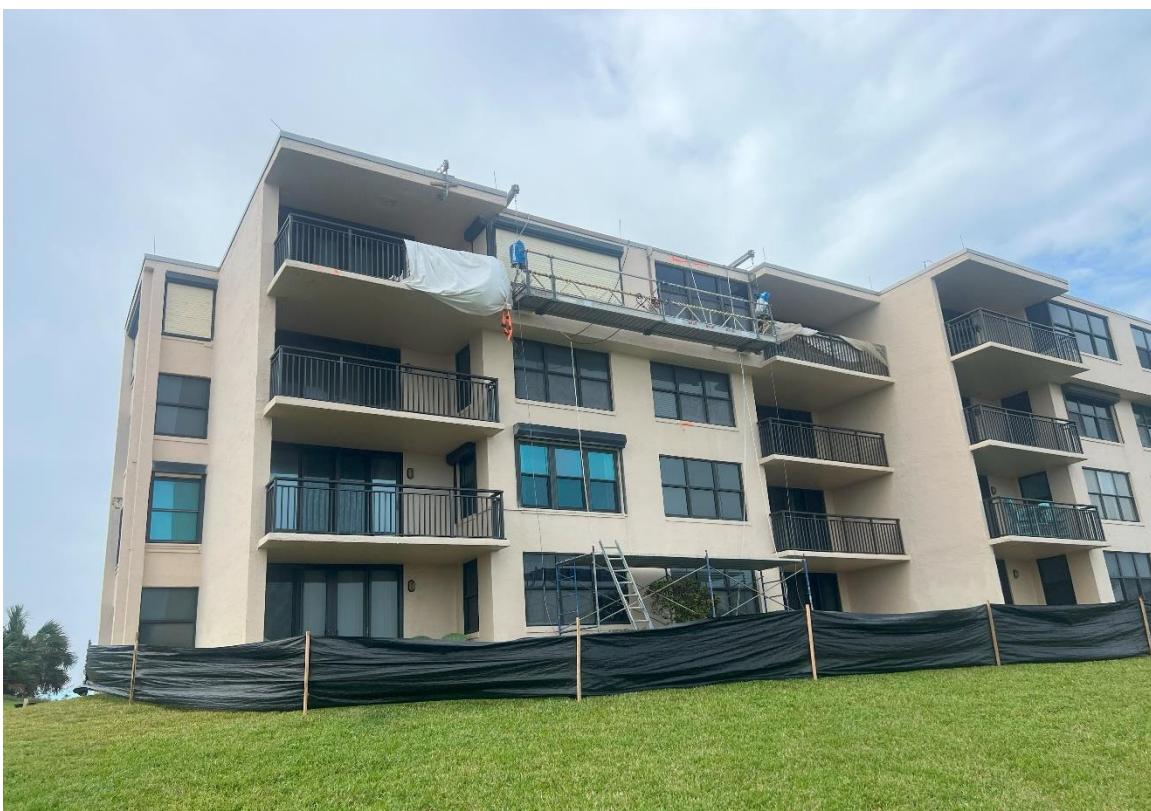
Figure 8. East Elevation View of Swing-Stages at 16 and 17-Stack Balconies.

The eight assigned employees continued to make steady progress during this two-week reporting period, beginning work on the 16 and 17-stack balconies while completing the 01-west balconies and the walkway activities.
