# **BAREFOOT TRACE CONDOMINIUM**

St. Augustine, Florida

## **FACILITY CONDITION ASSESSMENT**

### **Survey Report and Results**

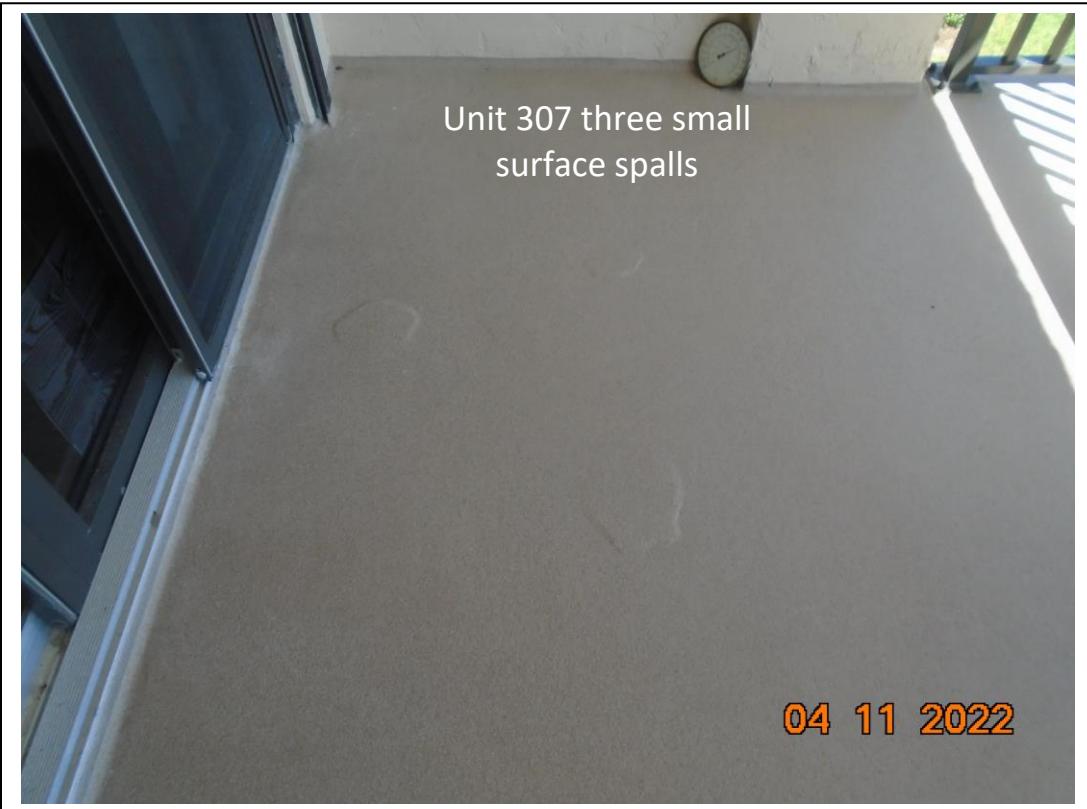
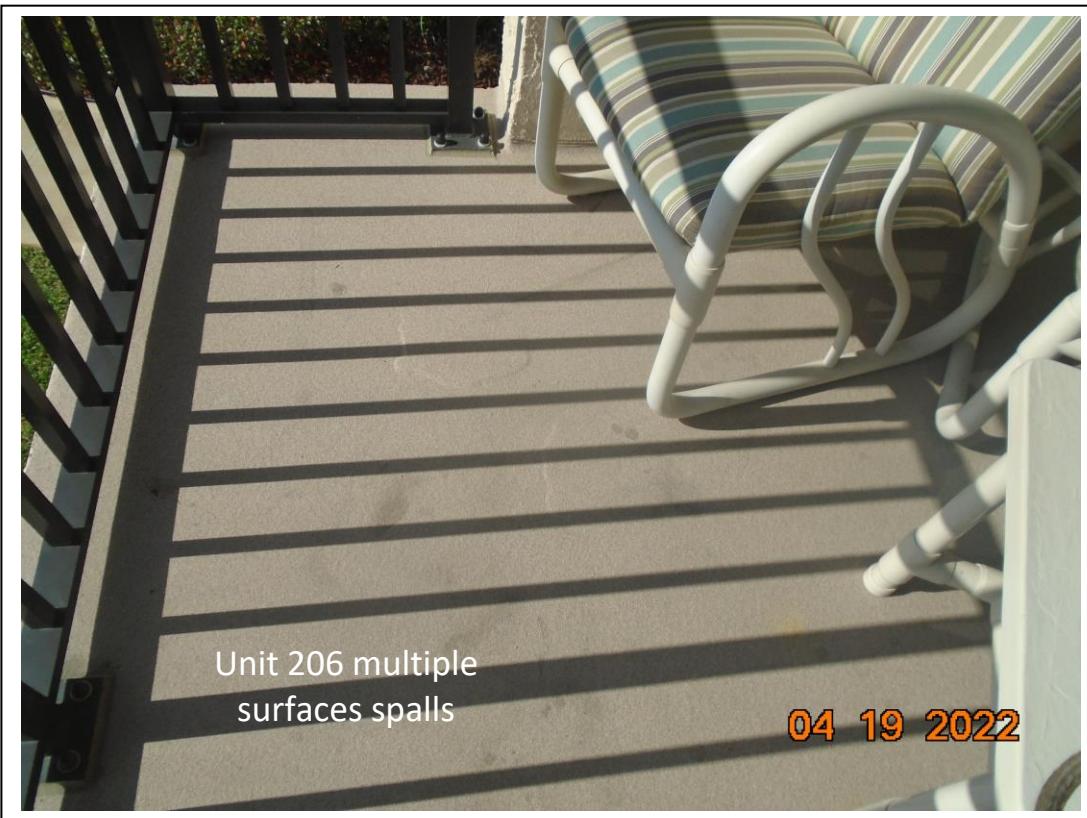
Example of possible  
encroachment at 215  
because of the size and  
proximity to the door  
threshold
